APPENDIX A PROJECT GRAPHICS

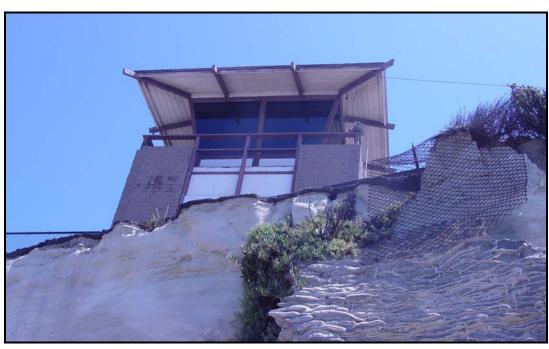
LOOKING UP FROM THE BEACH AT BLUFF EROSION AND LIFEGUARD HEADQUARTERS

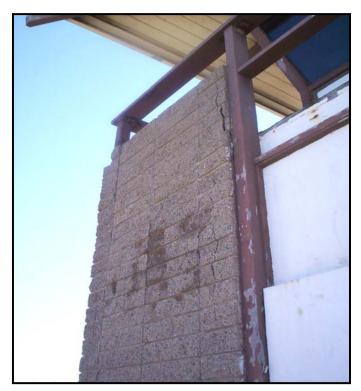
DETERIORATION OF THE LIFEGUARD HEADQUARTERS EXTERIOR

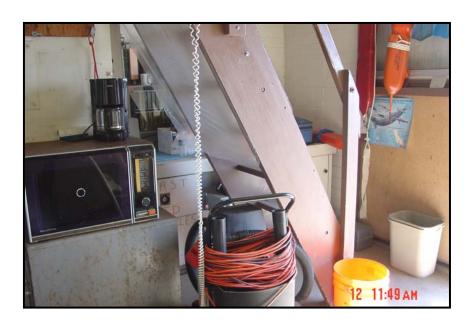
LIFEGUARD HEADQUARTERS INTERIOR SHOWING LACK OF SPACE
